REPORT NO. 0126062

STRUCTURAL PESTS & DRY ROT INSPECTION REPORT
 (Wood-Destroying Pests or Organisms)

ADDRESS OF PROPERTY INSPECTED 13706 SW Reindeer Ave. Bend, Oregon 97701 DATE OF INSPECTION 1/26/06
 Inspection ordered by Harold Homeowner
 Report sent to Jan Broker
 Owner's Name and Address Harold Homeowner 1988 Robin Wood Pl. Bend, OR 97702.
 CLIENT'S E-MAIL: harold@home.com.
 PHONE #: 385 5555.

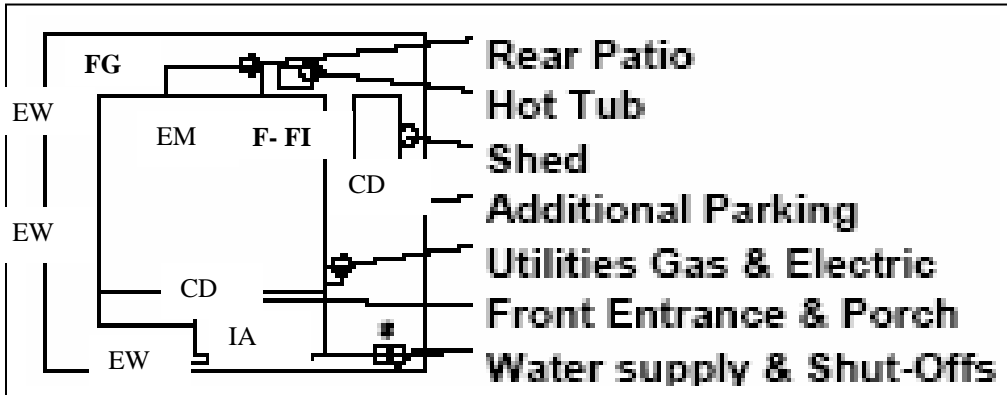
Negative slope observed at left side rear patio paver area causing run-off to flow to the foundation. During wet weather the water appears to pond up to: 1 inch, Evidence of moisture entry into the home at: Rear foundation due to poor run-off observed in exterior conditions. Recommend excavation and reversal of slope away from foundation.

Bio-organic growth was observed in the right rear area of the crawl space. Observed signs of moisture intrusion, which would promote this type of growth.

Cellulose (paper/wood) Debris observed in crawlspace and right side of house(wood pile), which can promote bio-organic growth and pest infestation. Recommend removal of all debris from crawlspace and exterior.

Substantial earth to wood contact observed on left side of structure and all fences right, front & rear. Recommend excavation of soil contact with wood structures creating positive slope away from structures.

Recommend further evaluation and treatment by a licensed mold inspector.
